Butuanon River: Understanding the Problem and Developing Sustainable Solutions

Part A. Research Report

Part B. Practical Solution

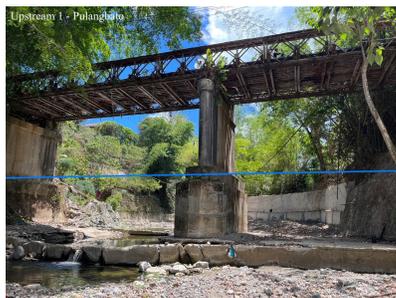
Figure 1. Upstream 1 Maximum Flood Height.

The researchers measured a maximum flood height of 4.72 meters (m) for Upstream 1 and 3.22 meters (m) for Upstream 2. As seen in Figure 1 and Figure 2 for Upstream 1 and 2 respectively, the maximum flood height exceeds the riprap of the river to a limited extent.

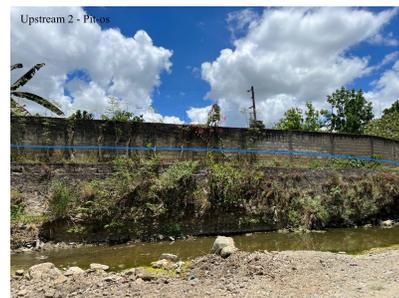
Figure 2. Upstream 2 Maximum Flood Height.

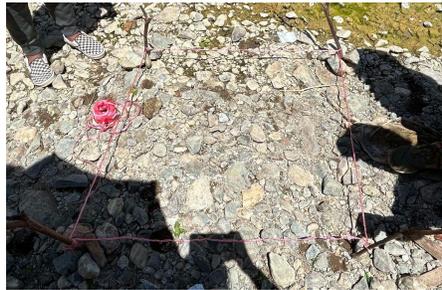
Figure 3. *Quadrant 1 located 2 m from the starting point.*

The researchers only performed the Randomized OSPAR Riverbank Monitoring method since there is very little trash found in the river, and each quadrant within the 100m distance is clean with no trash. There are 70 total items found in the 10 quadrants of the riverbank, and 22 of them are plastics.

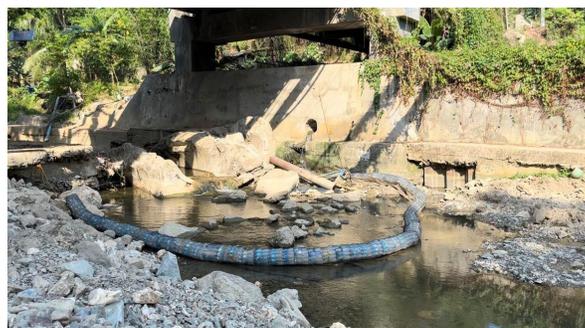
One of the current pollution control measures in place is the Biofence. This control measure is made of bottles wrapped in a net used to trap garbage implemented in Barangay Pit-os. The effectiveness of the Biofence is yet to be determined since this measure was only implemented during the week of the fieldwork. The researchers were able to observe pieces of trash collected by the Biofence which is an initial conclusion for its effectiveness.

Figure 4. Biofence located in the Butuanon River Upstream in Barangay Pit-os.

The existing pollution control measure in the Butuanon River Upstream, the Biofence, will be implemented in other areas of the river as well. Instead of the curved orientation that was the initial placement of the Biofence, the researchers propose to have it placed diagonally and attached from one end of the riprap to the other. The diagonal orientation of the Biofence can facilitate the movement of the solid waste to a designated area; thus, it will be easier to collect garbage since it is mostly concentrated in one area.
